## KSZ9031RNX Silicon Errata & Data Sheet Clarification

This document describes known silicon errata for the Microchip KSZ9031RNX device, which include the following variants:

The silicon errata discussed in this document are for silicon revisions as listed in [Table 1](#). The silicon revision can be determined by the device's top marking as indicated in [Figure 1](#). A summary of KSZ9031RNX silicon errata is provided in [Table 2](#).

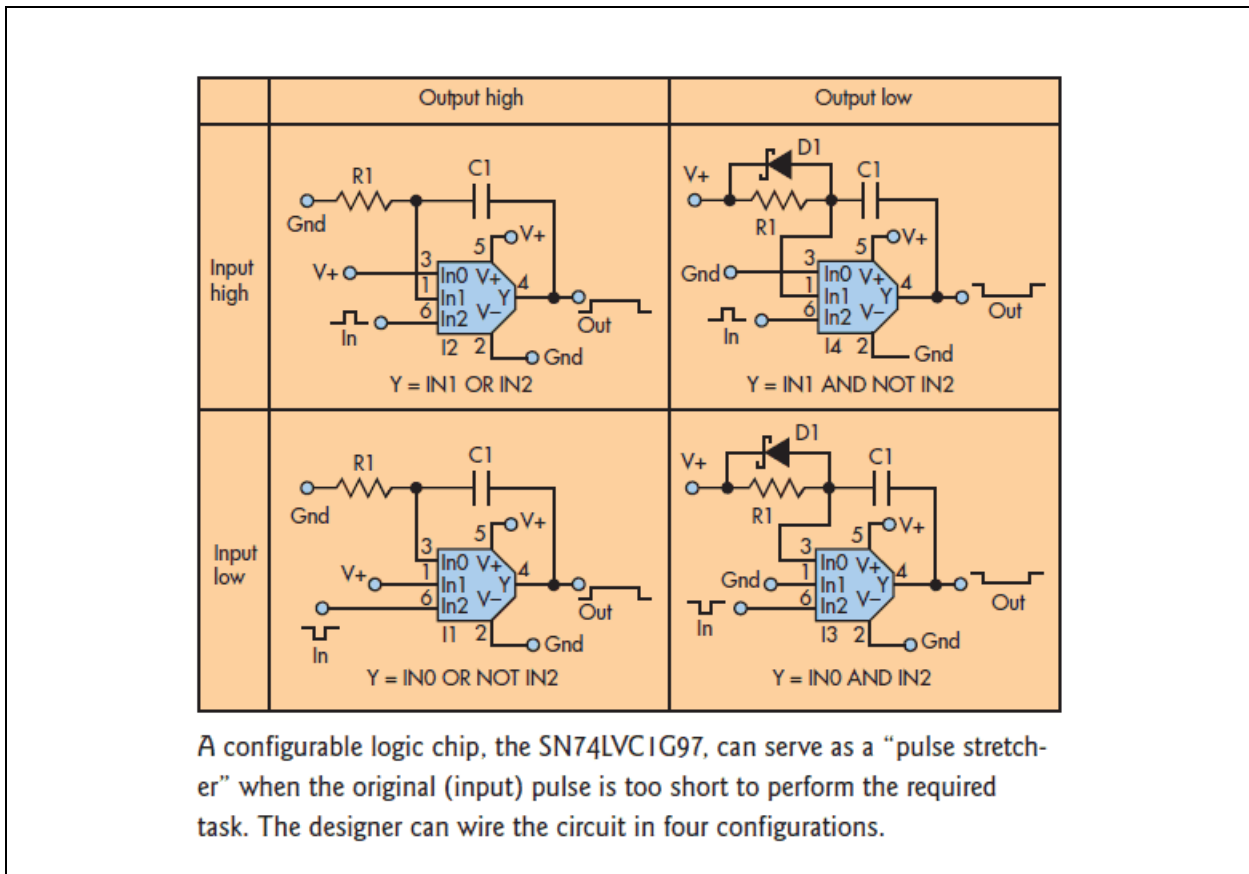
**FIGURE 2: LED CONFIGURATION**

In Tri-color Dual-LED mode, the LED[2:1] pin outputs toggle high pulses for transmit/receive activity indication. The high pulse width incorrectly tracks the activity data rate. At low data rate (e.g., one frame per second), the LED pin drives high (OFF) with a narrow high pulse width of about 640ns.

Typically, the LED toggle rate should be <10Hz (100ms clock period or 50ms high pulse width) to be visible to the human eye. A 640ns pulse is not visible.

If Tri-color Dual-LED mode must be used, use a pulse stretching circuit to detect high narrow pulse widths down to 500ns and stretch them to the visible width (e.g., >50ms). The following Electronic Design web link article has a sample pulse stretching circuit:

Use the Input high / Output high configuration, as shown in Figure 2 from the Electronic Design link. The output high stretch time is set by the time constant ( $R1 * C1$ ).

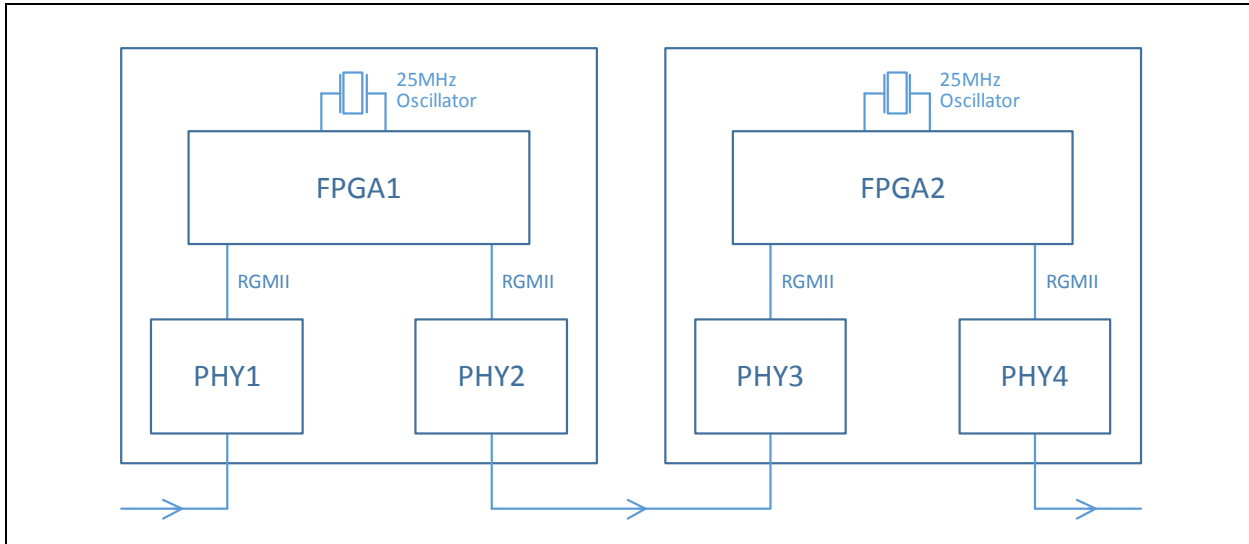
**FIGURE 3: DAISY CHAIN CONFIGURATION**

In a daisy chain configuration (PHY1 through PHY4 in [Figure 3](#)), 1000BASE-T receive traffic stoppage can occur at one of the device-to-device links in the chain.

The 1000BASE-T receive traffic stoppage at the local device (PHY3) is triggered by a single GTX\_CLK clock pulse assertion of the TX\_EN signal from the MAC (FPGA1) to the link partner device (PHY2). This scenario can occur after FPGA programming when the FPGA1 MAC transmit pins change to outputs. During the pins transition, if the TX\_EN signal is not driven by the FPGA1 and then floats high (gets asserted) for a single clock period at the PHY2 input, a GTX\_CLK output transition from low to high triggers the error condition.

Delay GTX\_CLK output from FPGA after programming to allow the TX\_EN output to be driven low first. Alternatively, add an 1 kohm pull-down at the TX\_EN input of the device.

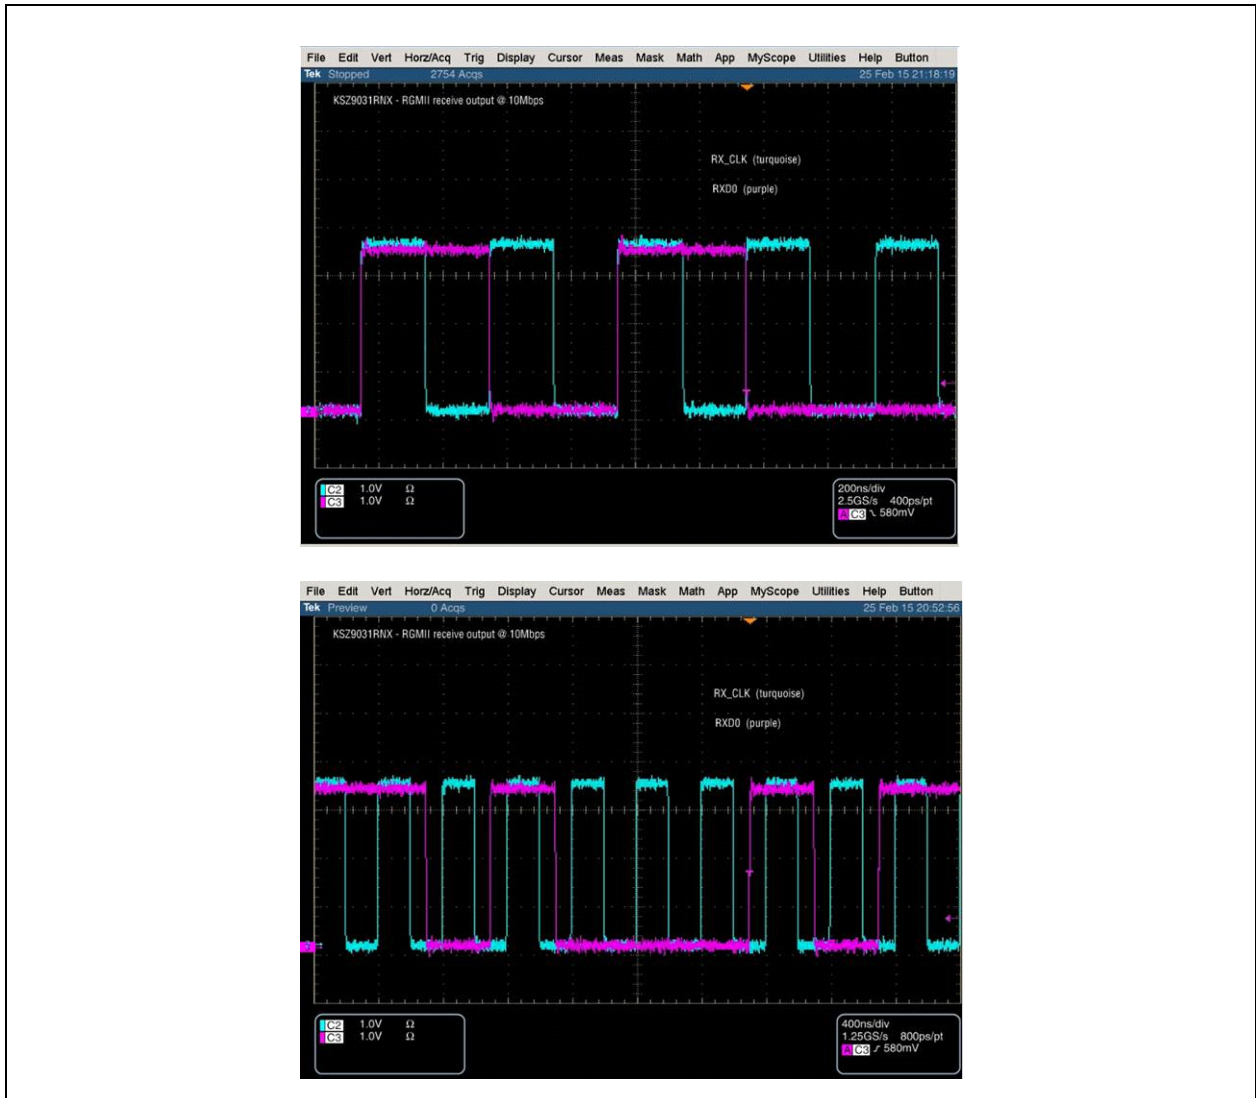
**FIGURE 4: RXD0 SCOPE CAPTURES**

In RGMII 10Mbps mode only, the device can power-up/reset to one of two possible clock phases. With respect to the RX\_DV and RXD[3:0] output high/low transitions, one phase transition is in sync with the RX\_CLK clock rising edge, and the other phase transition is 100ns before the RX\_CLK clock rising edge.

Figure 4 details scope captures of RXD0 aligned and not aligned (100ns before) with respect to the RX\_CLK clock rising edge. RX\_DV and RXD[3:1] have similar timings.

None. This anomaly is unlikely to cause timing problem with MACs. MAC chips have setup/hold times that are typically <10ns. There is plenty of timing margin to allow for the device's 100ns clock phase shift in a 400ns clock period.

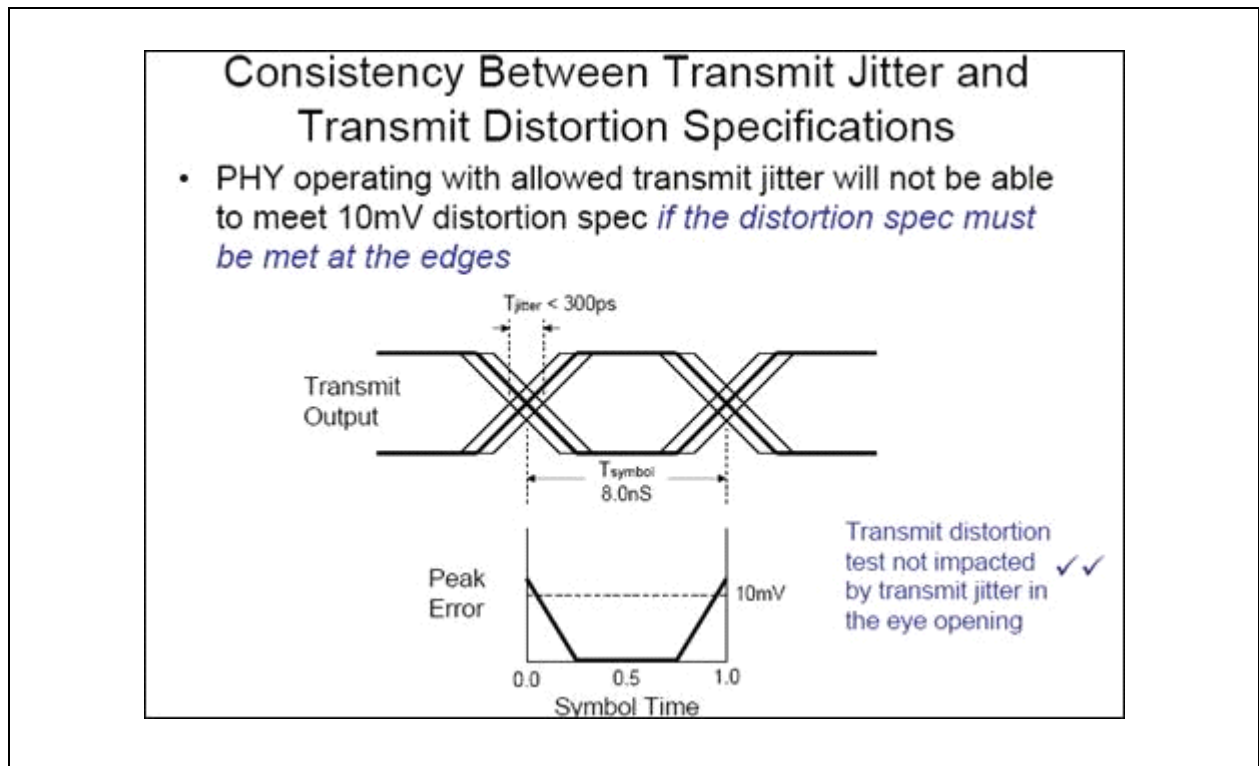
**FIGURE 5: IEEE DOCUMENT PAGE 6**

The device's 1000BASE-T Transmitter Distortion is in the 8-20mV range, versus the <10mV indicated in the IEEE specification.

IEEE testing calls for <10mV peak transmitter distortion for at least 60% of the UI within the eye opening. However, this measurement might not be valid, as the transmit distortion test is sensitive to transmit jitter. Refer to the explanation below, taken from the aforementioned IEEE document.

- On page 6, a contradiction between Transmit Jitter and Transmit Distortion requirements:
