# CMX-Topo path: CRC error investigation

Priscilla Pani and Eduard Simioni  
with help and inputs of Topo and CMX crews

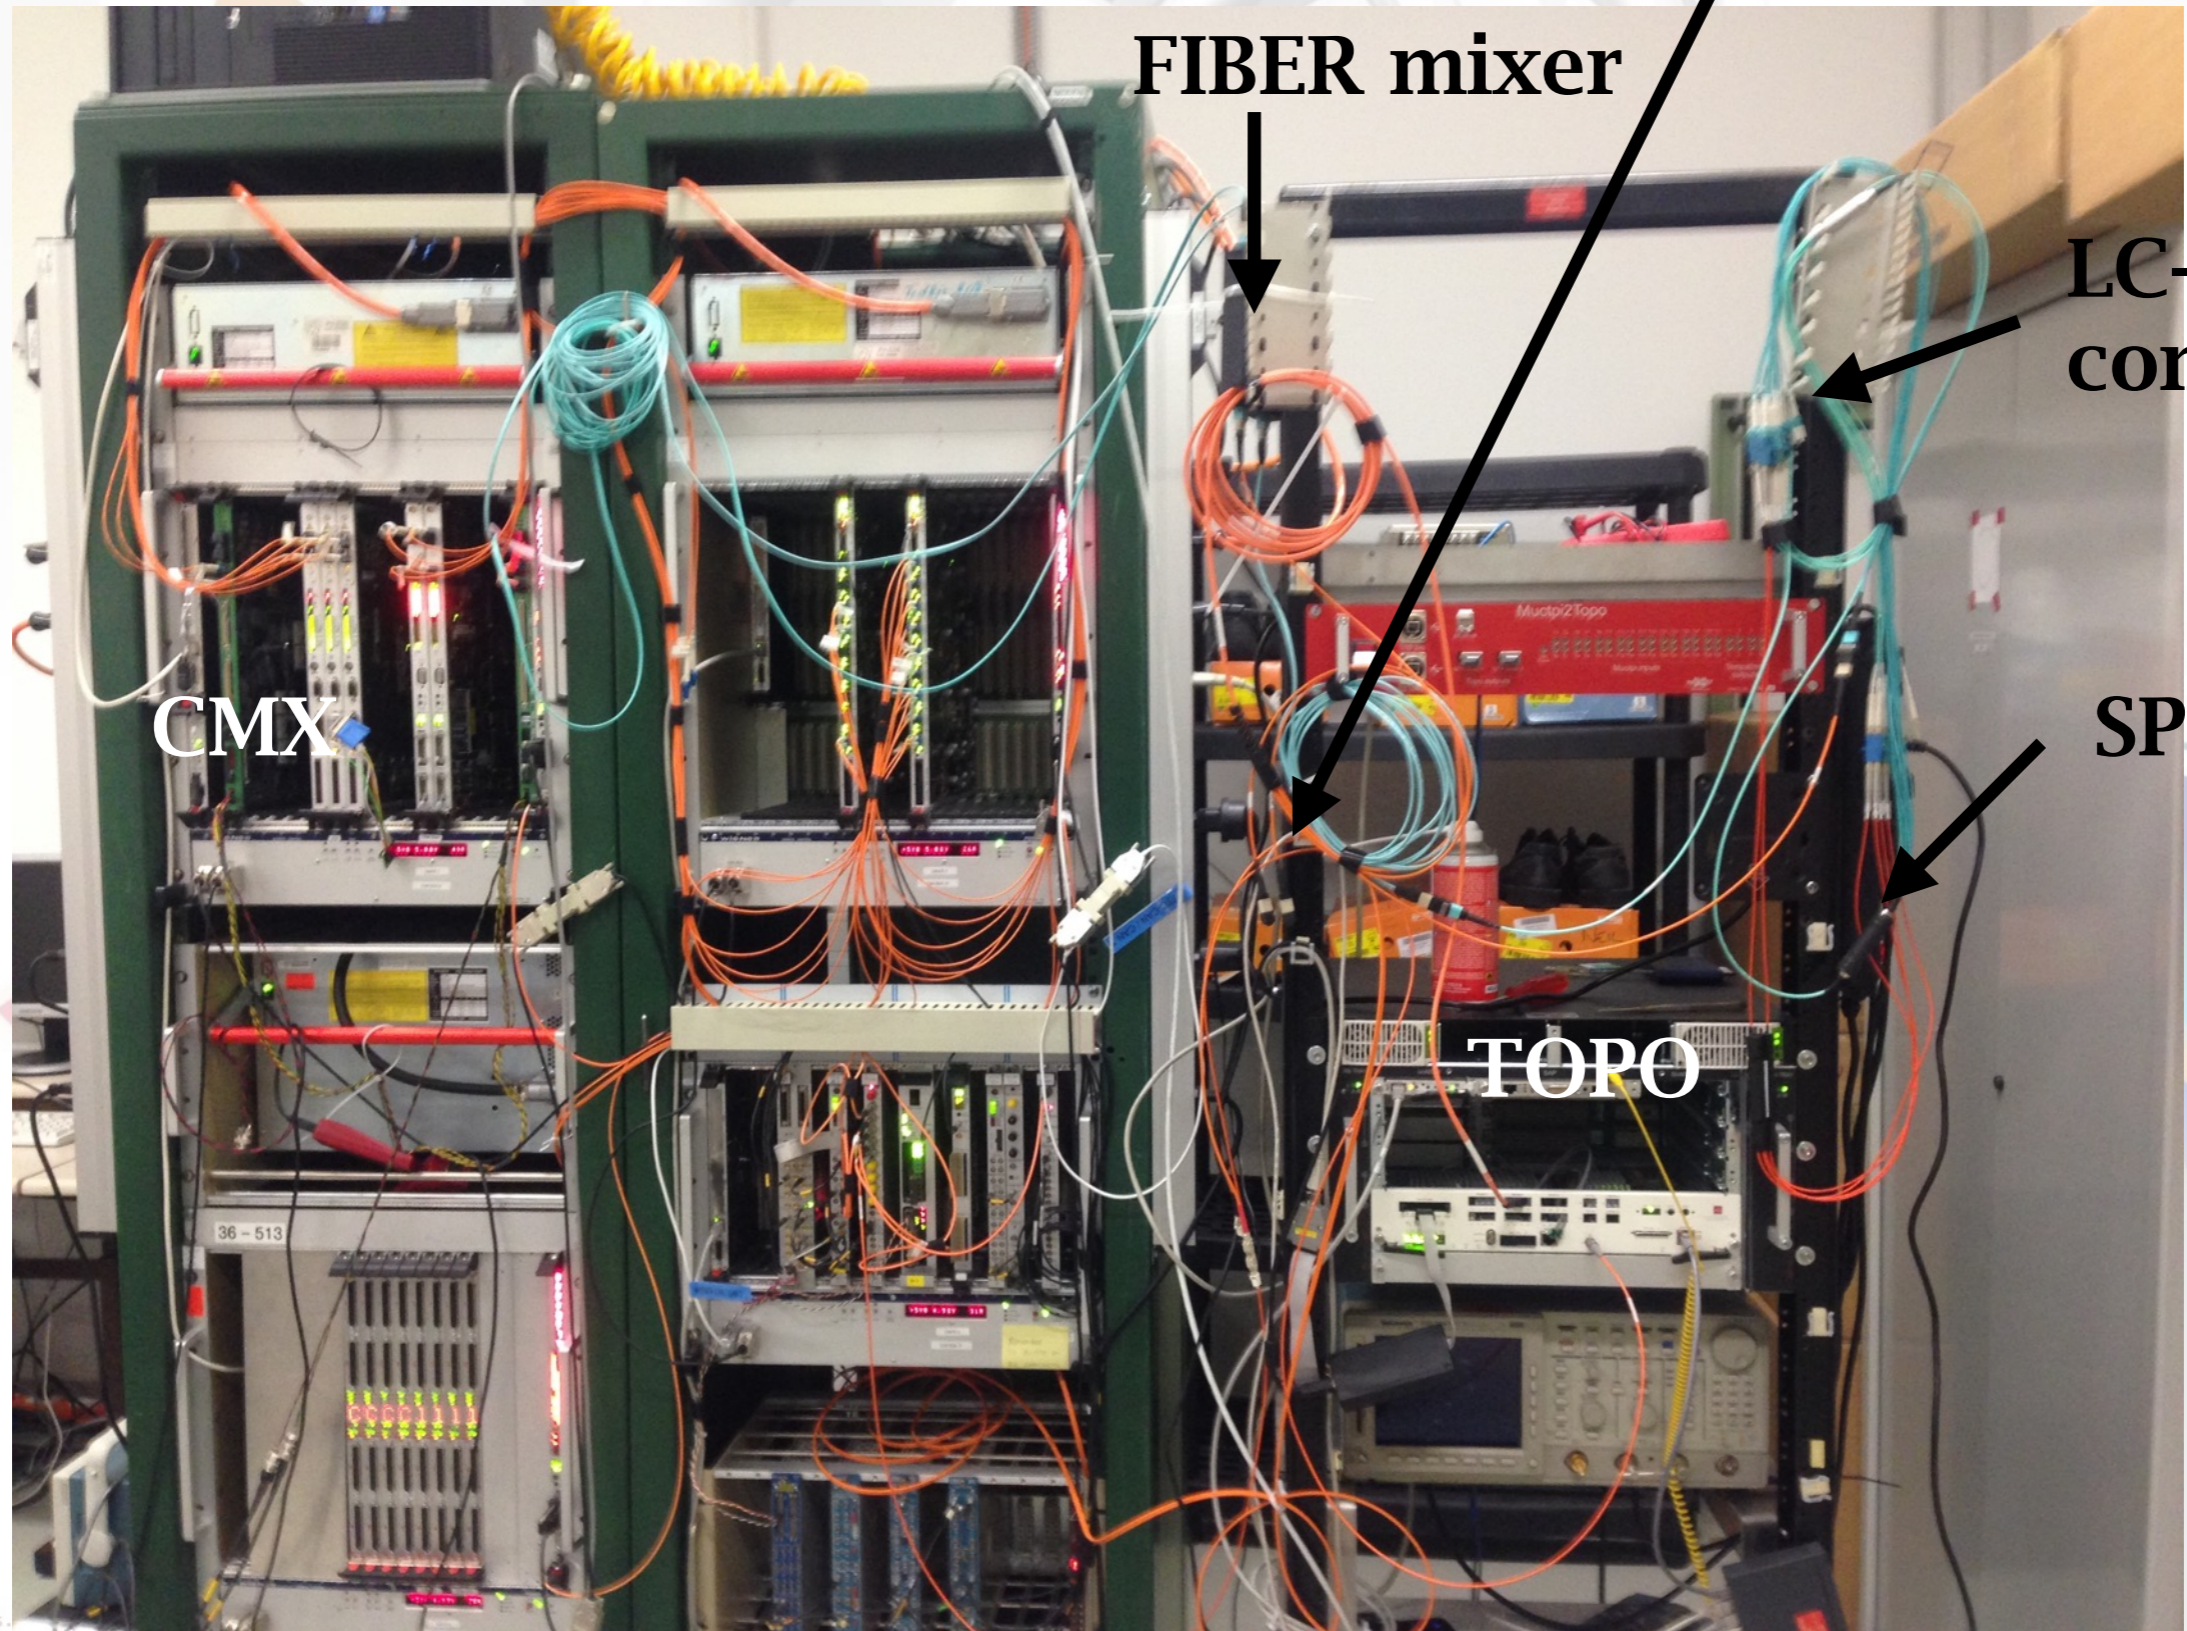
# Test-rig setup

- CMX: loaded with CP crate FW (both)

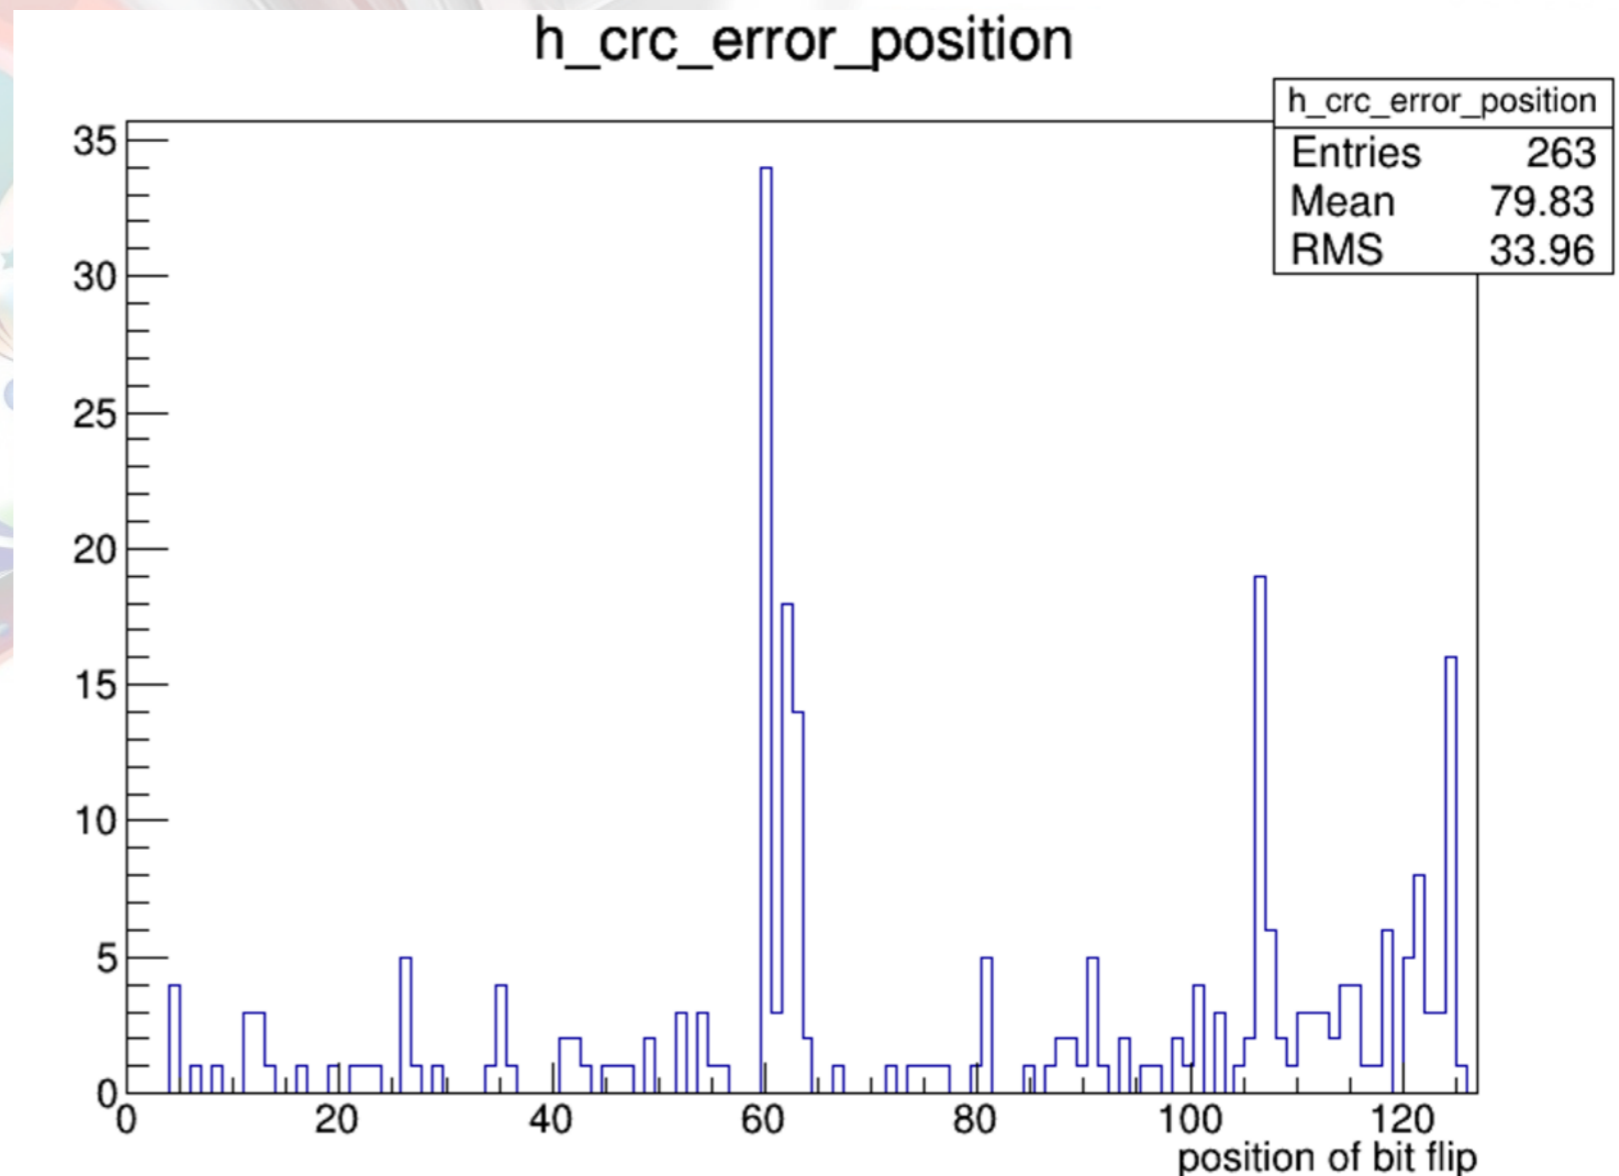
# Details (elogs: 290217-290259)

- sparse random PPM
- Most of events empty: expected to see the flip around the module and BCID number
- both 1 and 2 bit flips observed.
