# Problem with Limit Switches

## Spartan IR Camera for the SOAR Telescope

Edwin D. Loh

17 February 2007

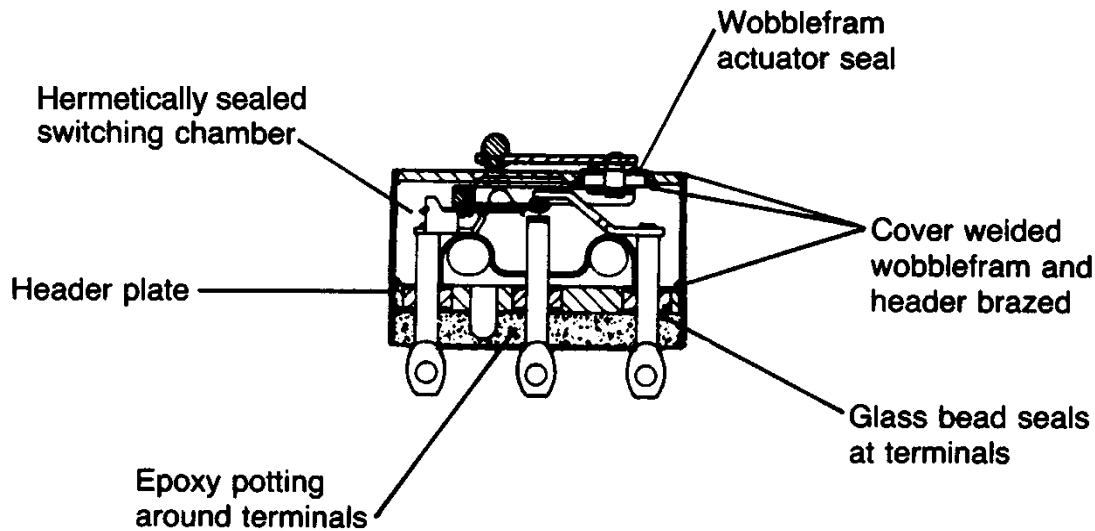
The rotation stages use the hermetically sealed switch 17HM6 from Honeywell (Figure 1). The movement of the arm is transmitted from the outside to the inside through the “wobblefram.” There are two circuits, one normally closed, which we use, and the other normally open. Because the switch is meant for a wide temperature range, its housing is metal.

Figure 1: Drawing of the HM switch from honeywell.com.

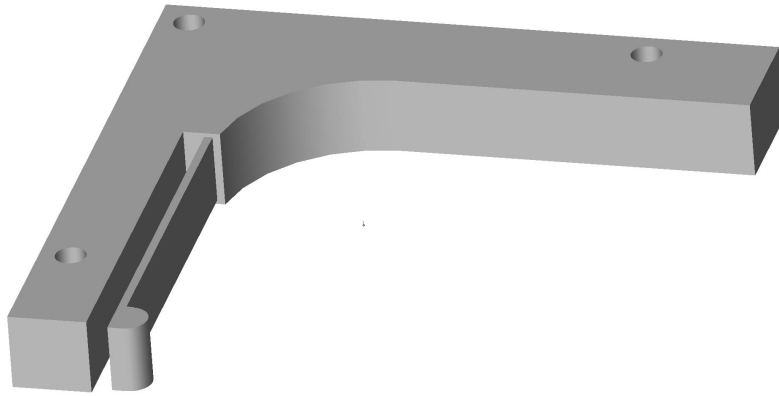
Figure 2: Old antibacklash spring/stop for the mirror arms. The new one will have antibacklash springs on both legs.

**Use forward limit switches for backup** The forward limit switch can be used as a completely redundant backup for the mask wheel, big filter wheel, and little filter wheel. The forward limit switches may not be used as is for the two mechanisms that move the mirror arms, because the antibacklash springs are engaged only near the reverse limit and the position where the mirror is in the light path. A new antibacklash spring/stop must be made for the two arms. The old one has an antibacklash spring on one leg for the in-path position and a stop on the other leg for the out-of-path position (Figure 2). The new one will have antibacklash springs at both the in-path and out-of-path positions. The software will have to compensate for the backlash, since the mechanism must move in opposite directions to insert the mirror in the light path and to locate the forward limit.

We recommend the second scheme because it will take less time. No wiring needs to be added. Installing the antibacklash spring/stop takes a day, since realignment is not needed. Testing takes a week.
