RAMSES CONCEPT

A NEW ACTUATOR CONFIGURATION

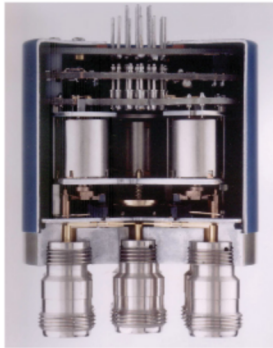
FIG. 2: CUTAWAY VIEW

Figure 2 shows a cutaway view of a RAMSES coaxial switch displaying the actuator mechanism. A second improvement involves a new rectilinear actuator design using high energy magnets and a switching performance in relation to its size.

To eliminate this problem of increased insertion loss in the contacts, RAMSES devices incorporate a patented system. This system, compresses two parallel blades suspended from a bearer, which enables the guiding and positioning of the commutation blades to be accomplished entirely outside the RF cavity. These blades impose a rectilinear motion on the switching pusher, suppressing both friction and the production of particles inside the RF cavity. The unique system is extremely small and can be used in all of RAMSES series switches.

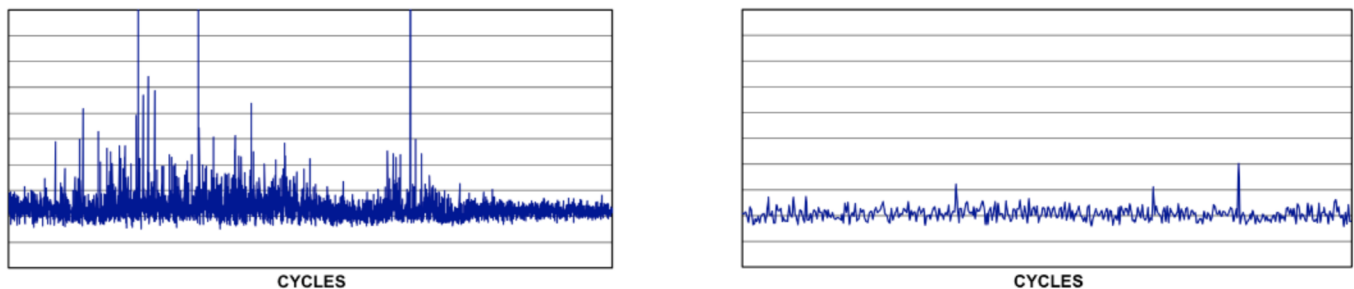
FIG. 4: A COMPARISON OF (A) CONVENTIONAL & (B) RAMSES SWITCH DESIGN CONTACT RESISTANCE DURING ONE MILLION CYCLES

RAMSES series switches have successfully survived tests of 10 million switching temperature cycles from -55 ° to + 85 °C while demonstrating good contact resistance stability. Visual inspection of these switches after testing has indicated that the RF lines were free of much of the contamination found during similar tests on traditional switches. A comparison of the actual measured contact resistance obtained from monitoring both conventional and RAMSES switches using several parts that have already been actuated one million cycles is shown in figure 4. Although the conventional switch may not be considered failure, its contact resistance has become unstable, thus degrading its reliability.
